**BASIC CREEK
DAM**

**ALBANY COUNTY, NEW YORK
INVENTORY NO. N.Y. 84**

**PHASE I INSPECTION REPORT
NATIONAL DAM SAFETY PROGRAM.**

11 FEBRUARY 1981

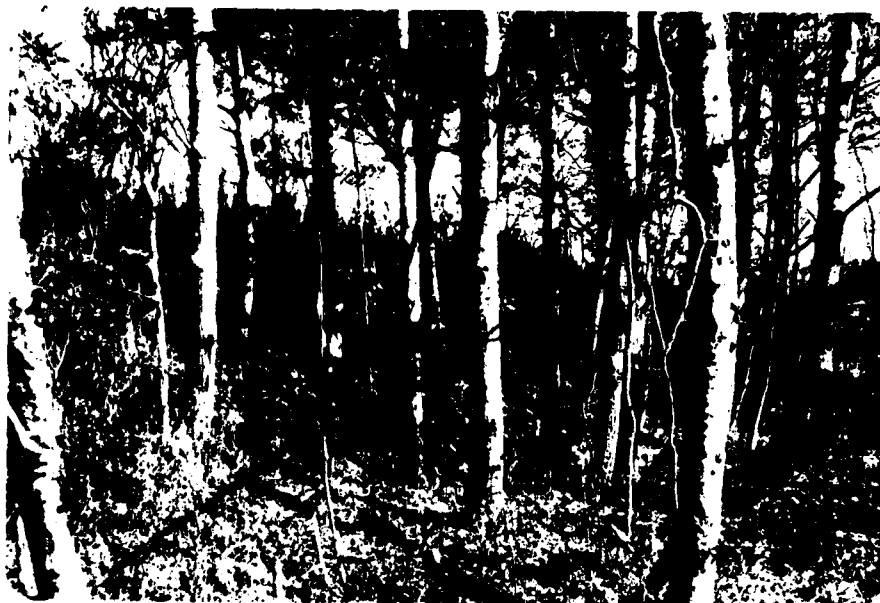
Photo # 8
Heavy tree and brush growth on downstream
side of right embankment.

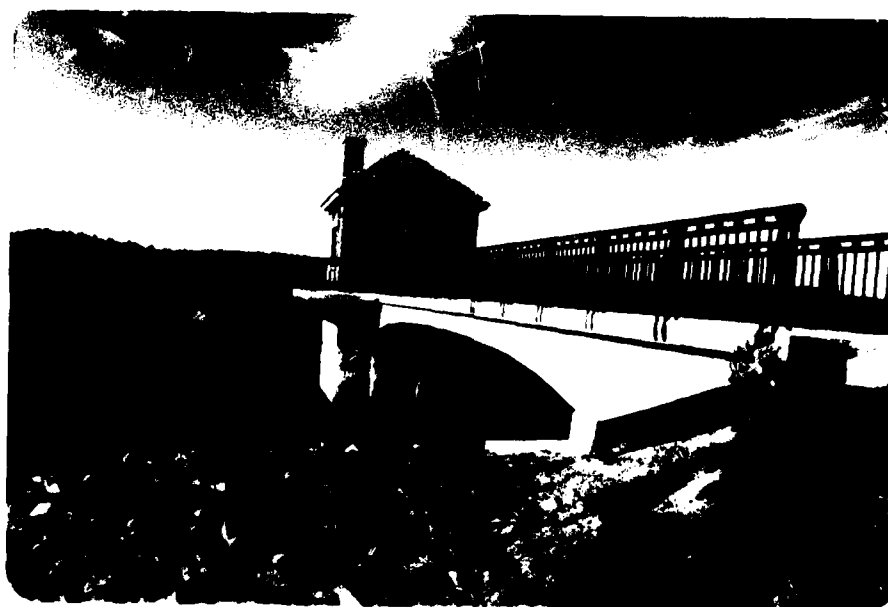
Photo # 9
Intake of diversion to Alcove reservoir (east side).
